# Manhole Inspection Summary

Manhole # S21CC\_009MH

Insp Date: **10/24/07 11:33 AM**

**Location** Address: **BEHIND 1906 RIGGS**

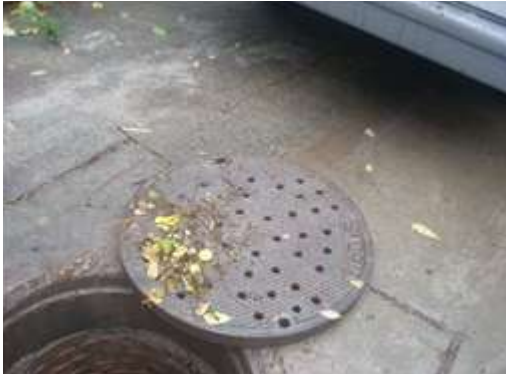
STORM DRAIN COVER

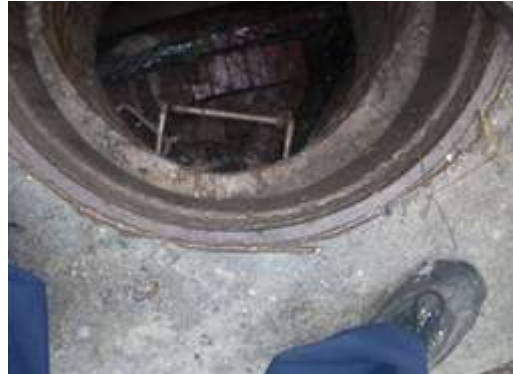
Defect 2

**Frame** Offset: **1** (in.) Condition: ☒ Sound ☐ Cracked ☐ Leaks

FRAME OFFSET

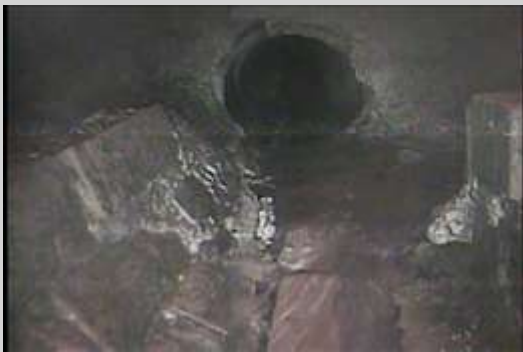
12 O'Clock Outflow

8 in. Circular Gravity Sewer  
Pipe Out @ 12 O'Clock

Pipe Height: **8.4** (in.) Rod and Bar (Angled)  
Pipe Material: **Clay** ☐ Pipe Lined  
Invert Depth: **8.31** (ft.) Flow Characteristics: **Slow**  
Deposits: ☒ None ☐ Mud ☐ Sludge ☐ Debris ☐ Grease  
Silt Depth: (in.) Deposits Extent:  
Infiltration: **None** Pipe Seal Cond: **Sound**

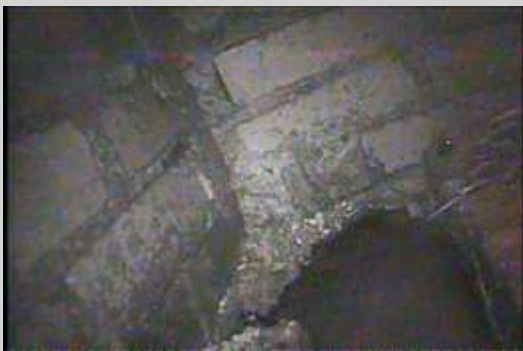
4 O'Clock Inflow

6 in. Circular Gravity Sewer  
Pipe In @ 4 O'Clock

Pipe Height: **6** (in.) Rod and Bar (Angled)  
Pipe Material: **Clay** ☐ Pipe Lined  
Invert Depth: **8.22** (ft.) Flow Characteristics: **Slow**  
Deposits: ☒ None ☐ Mud ☐ Sludge ☐ Debris ☐ Grease  
Silt Depth: (in.) Deposits Extent:  
Infiltration: **None** Pipe Seal Cond: **Sound**

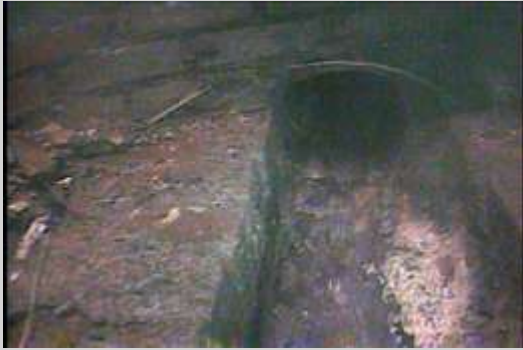
6 O'Clock Inflow

DEBRIS ON BENCH
